## 11 Appendix A: Support Structure Cracking and Repair Methods

### 11.1 INTRODUCTION

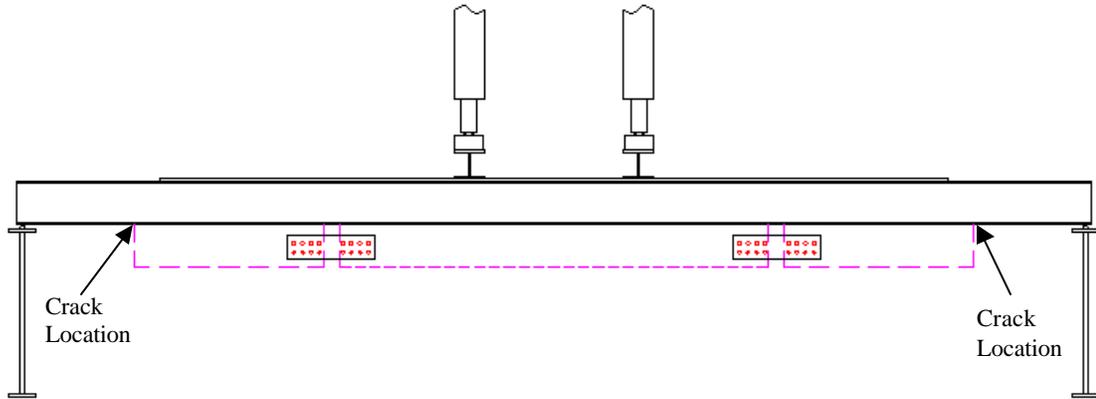
Initially there was no smooth contour used to gradually taper the added web. Excluding the taper caused a high stress concentration at the fillet weld terminations. These fillet weld terminations were located 20-cms from the support. It was thought that the net section stress at this point would be below the S-N fatigue limit for fillet weld terminations, a Category E detail in the AISC Steel Design Manual. The stress ranges exceeded the constant amplitude

fatigue limit (CAFL), however, and cracking ensued at all four corners. The figure below illustrates the point of cracking.

Figure 11-4: Initial testing setup with abrupt web terminations.

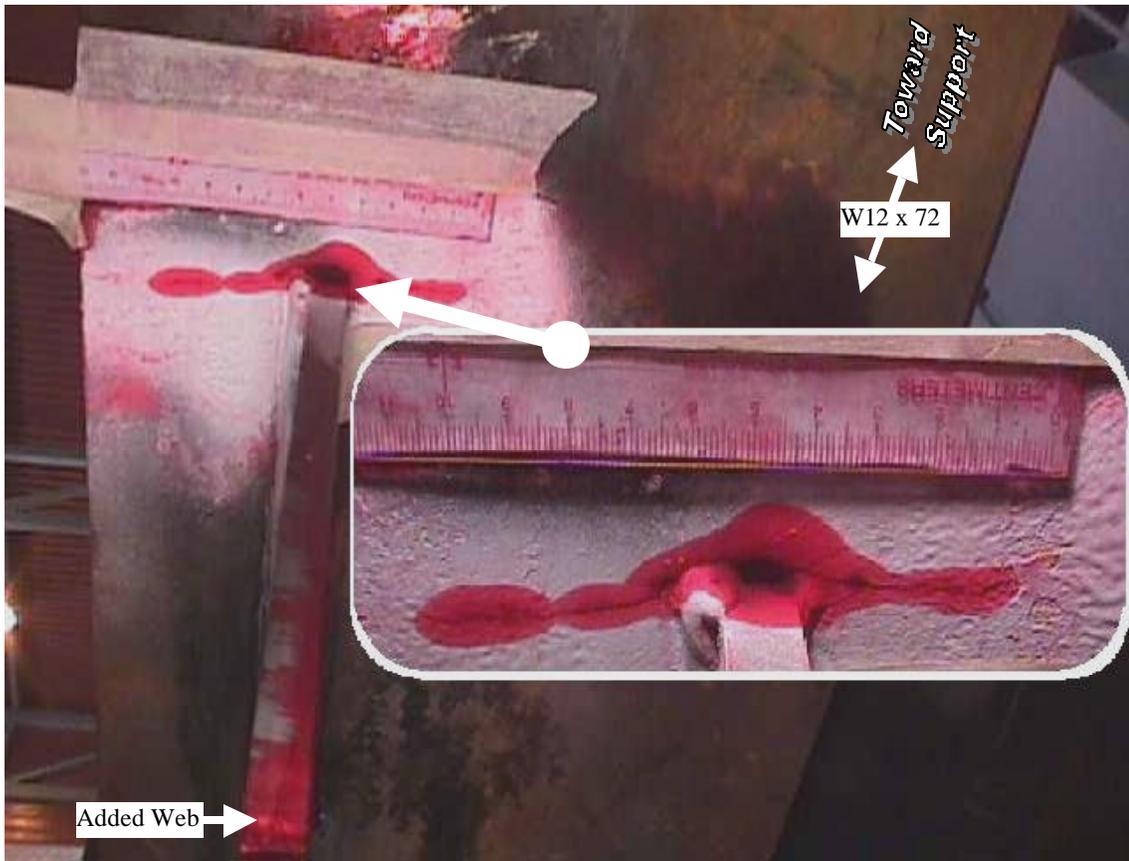
A typical crack may be seen in Figure 11-5. These were relatively long, through-thickness cracks that had not yet entered the beam web. Although the cracks were located at all four corners of the structural setup, they were not noticed until a detailed inspection was performed. An appreciation for the difficulties of field inspection may developed from this experience. Tab 11-1 displays the monitored development of the cracks and corresponding repair procedure.

Figure 11-5: Typical crack at fillet weld termination of added web.

The dye in Figure 11-5 is used to help visualize the extent of cracking in the lower flange of the I-beam. Notice the offset of the added web from that of the flange centerline. The eccentricity of the added web was necessary to maintain alignment with the specimen webs.

Crack Description	Corner Location/Through-thickness final length (mm)	Estimated Stress Range	Estimated Number of Cycles	Repair Method (More detail follows)
Fillet weld termination	SE: 100 NE:105 SW: 110 NW: 45	39 MPa	1.2x10 <sup>6</sup>	Remove part of added web, drill out crack tips, butt weld crack in flange between drill holes, add contoured web

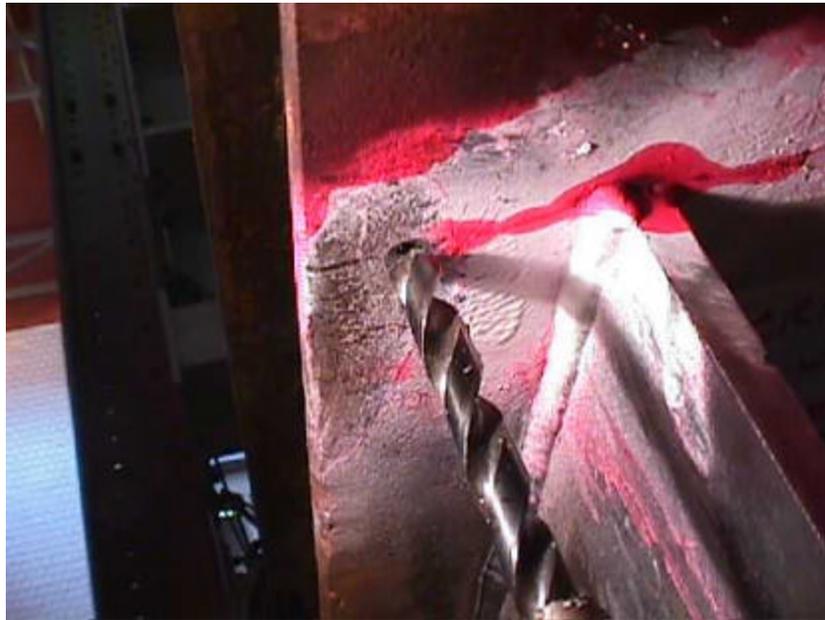
Figure 11-6: Drilling out the crack tips.

The first step in the repair was to locate the crack tips. This was performed with the red penetrating dye previously discussed in this report. A 19-mm hole was drilled at the crack tips once they were located. A photograph of one crack tip being drilled out may be seen in Figure 11-6.

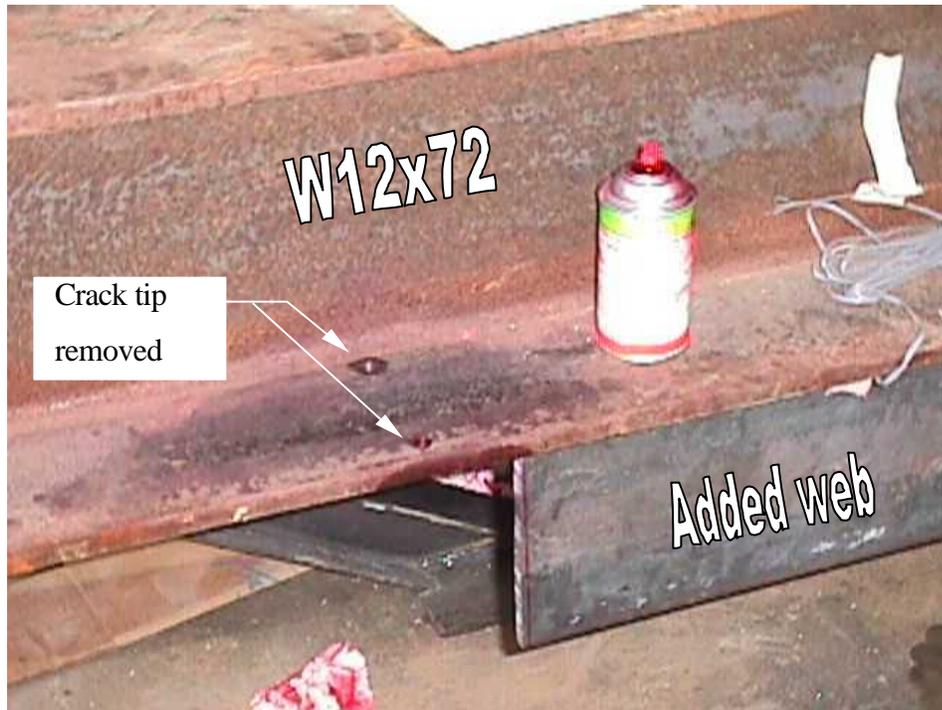
Figure 11-7: Drilled out crack tips in beam flange.

Drilling out the crack tips removes any existence of a sharp notch that might promote further cracking. A typical location with holes drilled at the crack tips may be seen in Figure 11-7. With the crack tips drilled out, a 10-cm portion of the added web was removed to increase accessibility to the cracked region. A reciprocating saw was used as seen in Figure 11-8.

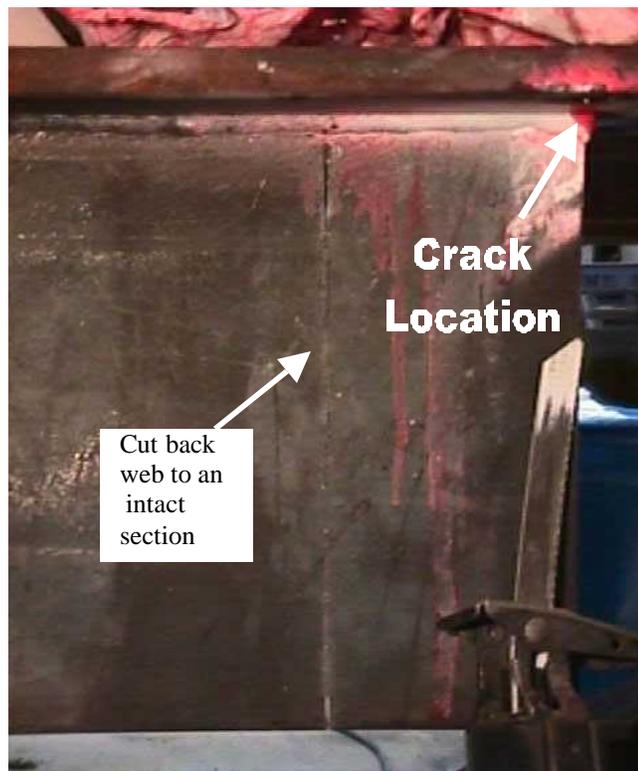
Figure 11-8: Increasing accessibility for weld repair.

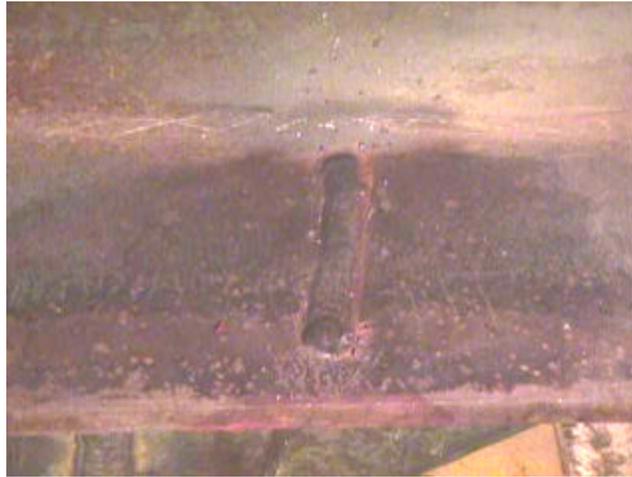
Figure 11-9: Resultant weld between drilled-out crack tips.

Increased accessibility to the crack allowed a complete penetration weld to be made between the drilled holes. The end result may be seen in Figure 11-9. Normally one should not weld the drilled holes shut as this creates an area of high constraint once the weld cools. Instead, the weld should be made between the holes and the holes should be enlarged to remove any roughness that might exist at the weld termination.

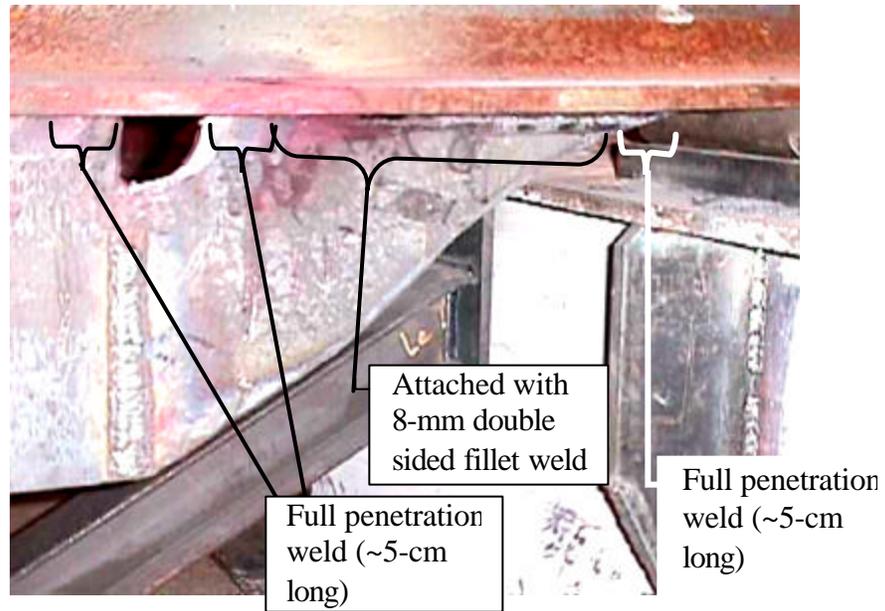
Figure 11-10: Attachment of contoured web to existing web.

After repairing the cracks in the beam flanges, an overall improvement to the added web termination was necessary. The abrupt termination of the added web was replaced with a contoured web. The addition of the contoured web termination may be seen in Figure 11-10.

It was predicted that adding the contoured web would gradually transfer the force from the web into the support beam. For increased fatigue resistance, the terminations of the added web were made with full penetration welds. The remainder of the contour was attached with 8-mm double sided fillet welds.

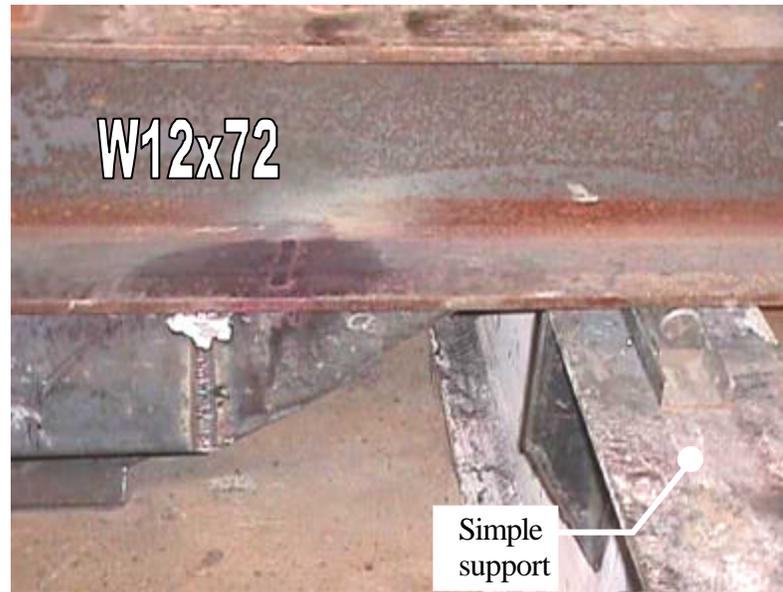
Figure 11-11: Typical repair for web terminations at four corners.

The contour web addition was made to all four corners of the support structure. A picture of the resultant repair may be seen in Figure 11-11.

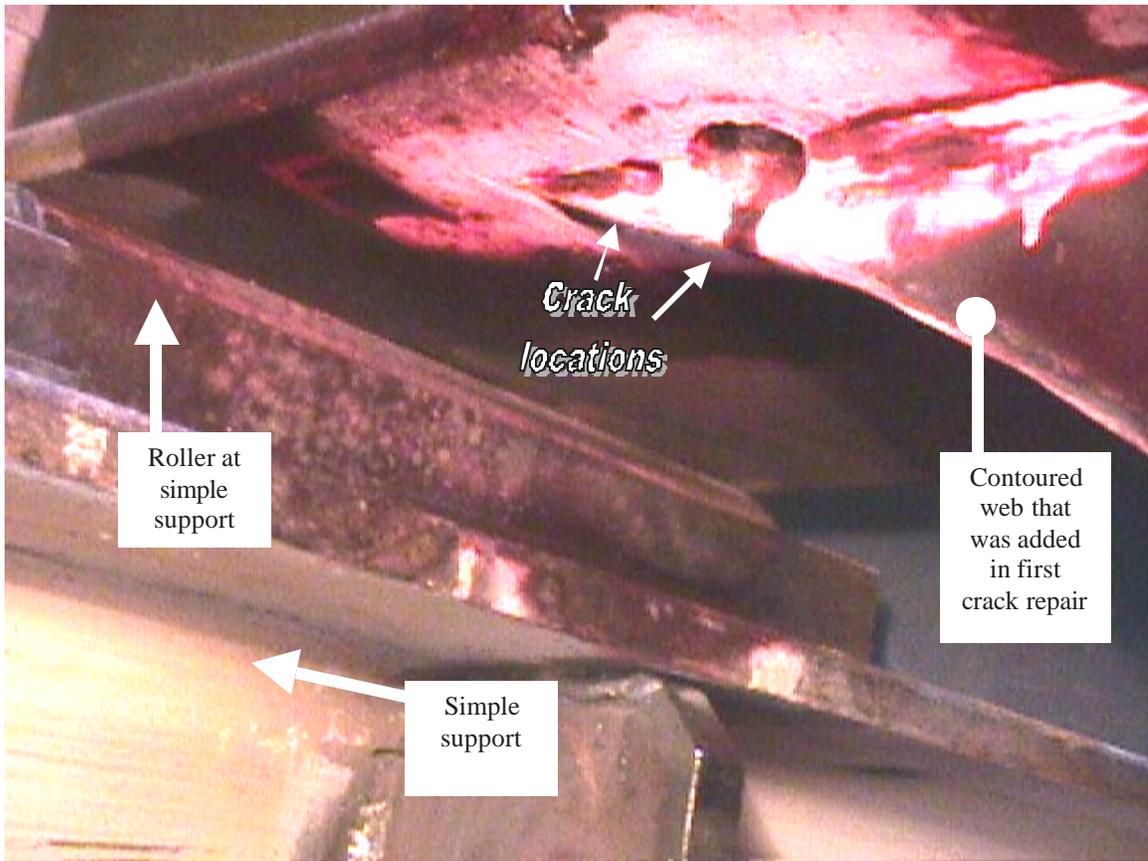
Modifying the abrupt termination of the added web was originally predicted to solve the fatigue cracking issue at these locations. It was soon found, however, that the state of stress was high enough even near the support to induce fatigue cracking. Fatigue cracks developed at both the contour web terminations and the weld access holes. All of these locations had been improved with a full-penetrations weld. Several small defects, however, were noticed in the welds. Fatigue cracks initiated at these flaws as well as in the base metal of the added web. These cracks had grown to an average length of 15-mm within  $1.5 \times 10^6$  cycles. Parallel cracks were noticed at several corner locations indicating that a large amount of stress existed in the region. The crack tips were immediately drilled out once the crack had progressed into the beam flange. Figure 11-12 and Figure 11-13 show a pair of cracks emanating from the end of the contoured web termination with the crack tips already drilled out.

Figure 11-12: Cracking in full penetration weld after contour repair was made.

Table 11-2 presents the crack details and history. The only repair that could feasibly address this problem area was drilling out the crack tips. Hole drilling has been used for years as a crack arrestor. By drilling a hole at the crack tip, two goals are accomplished:

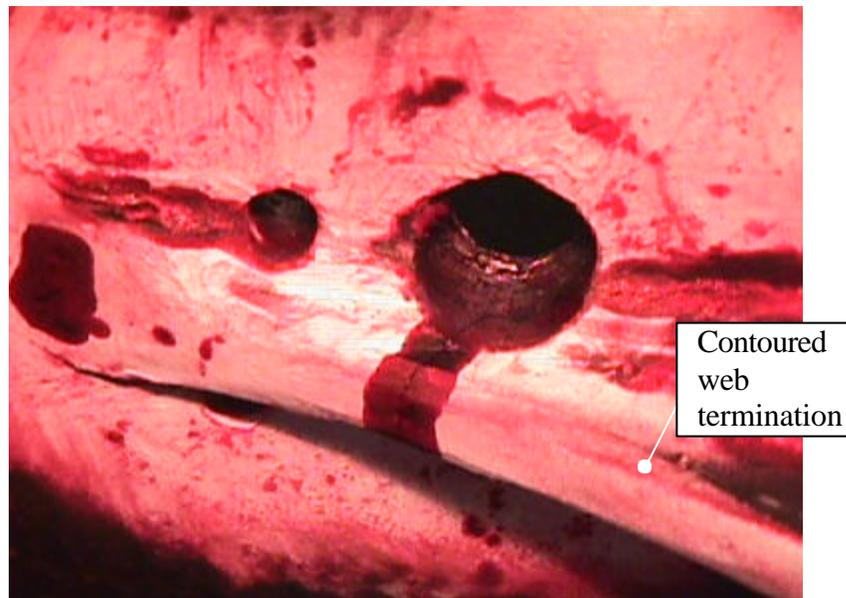
Figure 11-13: Detail of crack occurring in full penetration weld with tips drilled out.

Crack Description	Corner Location/Crack Length (mm)	Estimated Stress Range	Estimated Number of Cycles	Repair Method
Full penetration weld termination	SE: 15	55 MPa	2.5x10 <sup>6</sup>	Drill hole at crack tips. Hole diameter ~1/3-1/2 crack length
	NE:12	55 MPa	2.5x10 <sup>6</sup>	
	SW: 20	55 MPa	2.5x10 <sup>6</sup>	
	NW: 12	55 MPa	3.0x10 <sup>6</sup>
